SUBJECT: Gulfco Marine Maintenance Superfund Site
Condition of Storage Tanks and Former Impoundment Cap

On March 9, 2010, I performed an inspection of the above ground storage tanks and the cap over the former impoundments located at the Gulfco Marine Maintenance Superfund Site at 906 Marlin Avenue in Freeport, Brazoria County, Texas. Pictures of the tanks and cap are attached.

**GULFCO MARINE MAINTENANCE SUPERFUND SITE
INSPECTION, MARCH 9, 2010**

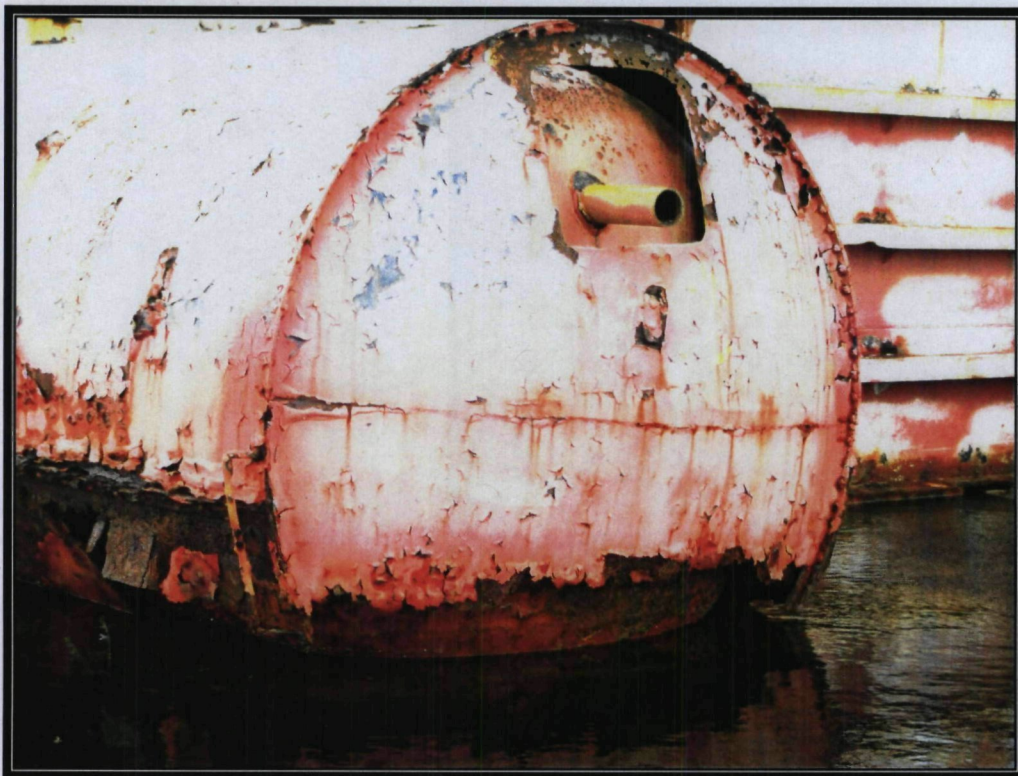
Tank #2

- (a) Tank No. 2 (organic phase, TCLP data):
 - Chloroform (2.25 mg/L)

- 1,2-Dichloroethane (8.4 mg/L)
 - Trichloroethylene (1.52 mg/L)
 - Vinyl Chloride (0.247 J mg/L)
- (b) Tank No. 13 (oily sludge, TCLP data)
- Benzene (13.8 mg/L)
 - 1,2-Dichloroethane (2.73 J mg/L)
 - Tetrachloroethylene (47.7 mg/L)
 - Trichloroethylene (2.98 J mg/L)
- (c) Tank No. 18 (light organic phase, TCLP data)
- Chloroform (216 mg/L)
 - Heptachlor (0.029 J mg/L)
- (d) Tank 21 (oily water, TCLP data)
- Benzene (51.6 J mg/L)
 - Chloroform (2100 mg/L)
 - 1,2-Dichloroethane (224 mg/L)

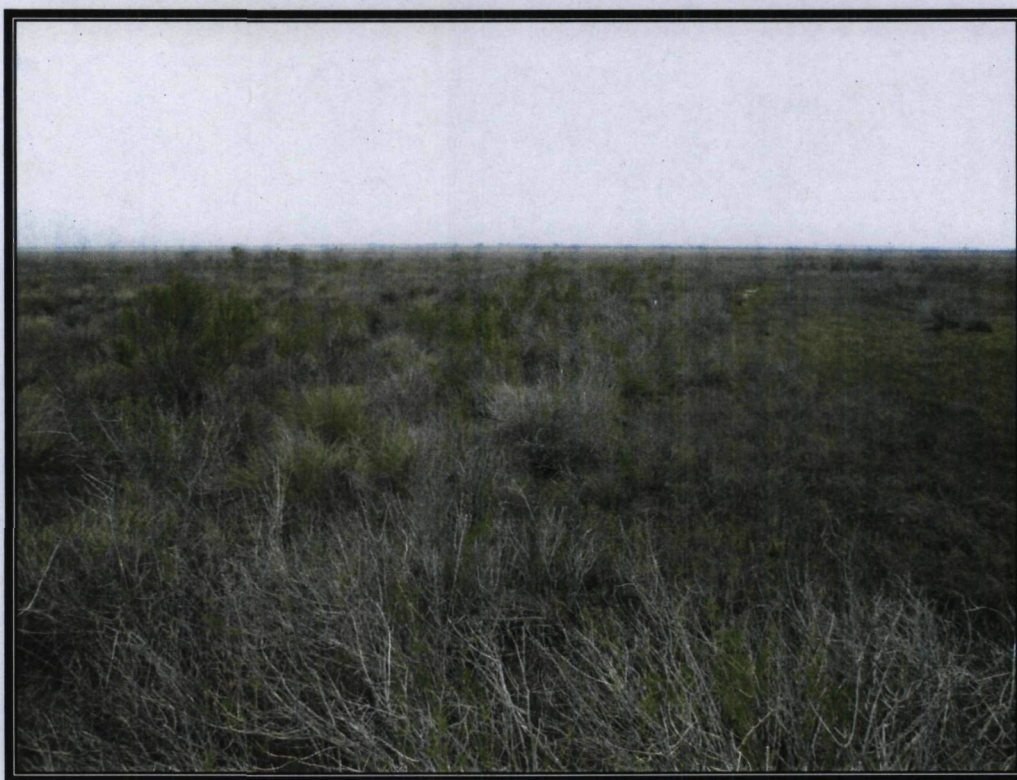
Former Impoundment Cap: east corner, view northwest

The purpose of the clay cap is to prevent direct exposure to the underlying hazardous substances, and to restrict infiltration of rain water and migration of the hazardous substances in the shallow groundwater. The cap was observed to have ruts on the top, and was covered in some areas by woody shrubs reaching a height of approximately three to four feet. These ruts may erode to the point of exposure of the contaminated materials below the cap. In addition, the ruts and the roots from the woody shrubs will likely result in increased infiltration through the cap, and migration of the hazardous substances beneath the cap into shallow ground water, the surrounding soils, and surface waters.

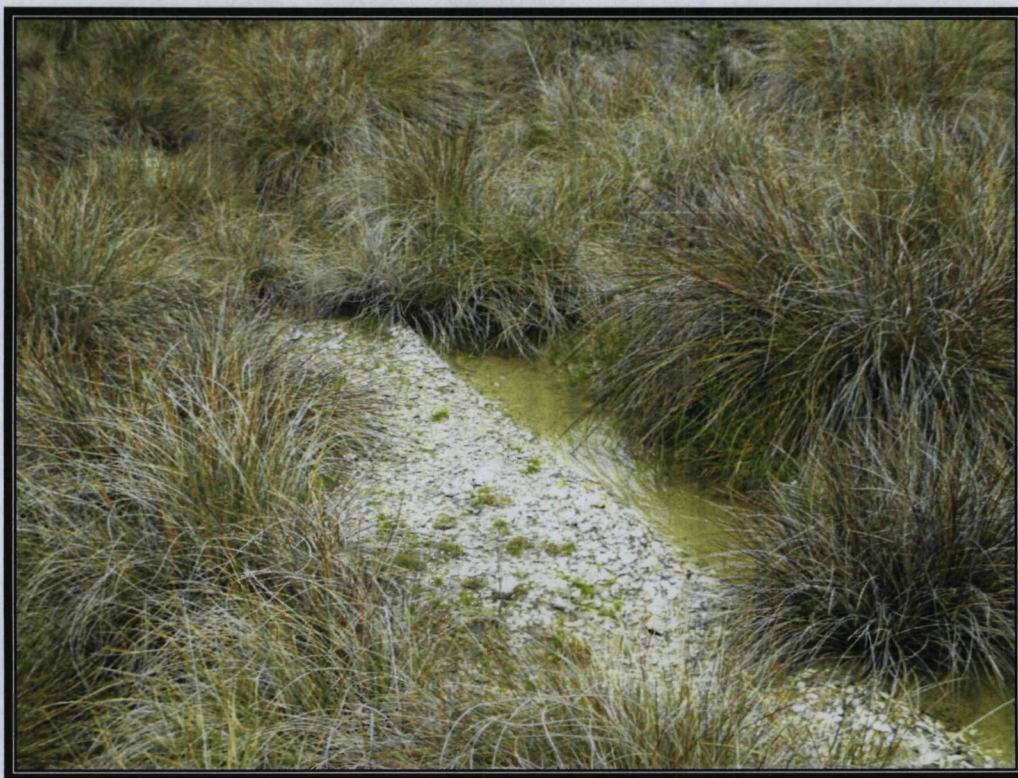
Former Impoundment Cap: rut on top of west side of cap

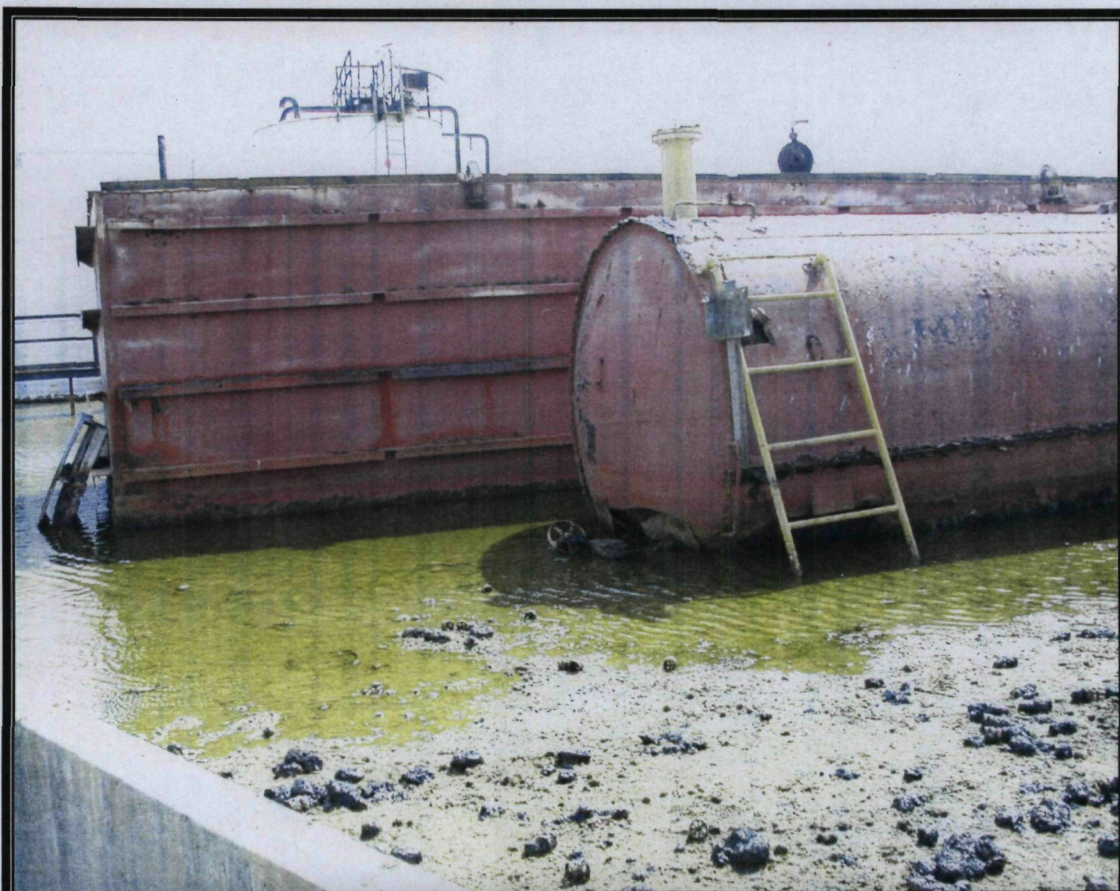
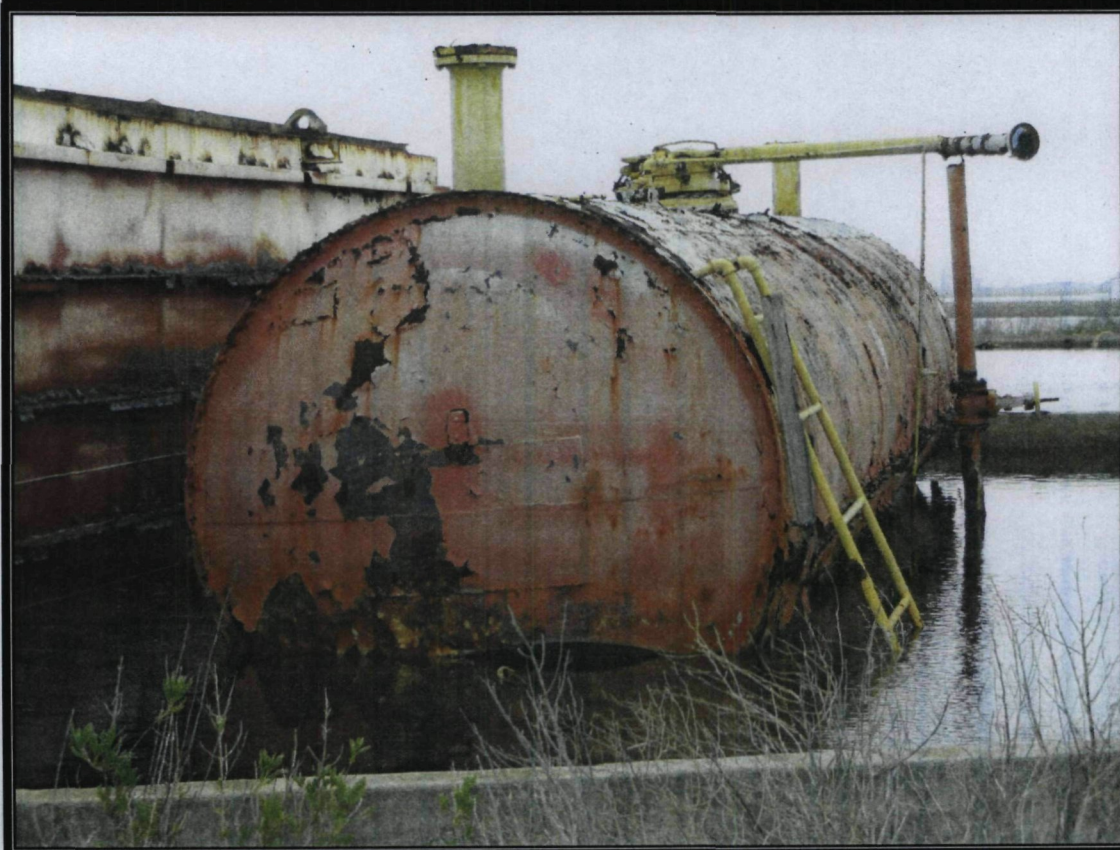
Tank No. 2 (round tank)

An above ground storage tank farm is located at the site south of Marlin Avenue. It consists of fourteen tanks of various sizes located within a concrete bermed area. In 2008, wind and/or storm surge resulting from Hurricane Ike removed a fifteenth tank. These tanks contain various hazardous substances including benzene, 1,2-dichloroethane, chloroform, heptachlor, tetrachloroethene, trichloroethene, and vinyl chloride. Corrosion was observed on the tanks which resulted in complete penetration of the metal in at least one case (Tank No. 2). The containment areas were approximately one-half full with water. Since 2003, there has been additional deterioration and corrosion of the tanks, including the tanks (Tank Nos. 2, 13, 18, and 21) that contain hazardous substances as identified below. Pictures of these four tanks taken in 2003 and 2010 are attached. This corrosion will continue as a result of the site's location near the coast, and will likely result in future releases as the tanks continue to deteriorate. In addition, the site's location within the 100-year floodplain and further tank deterioration make it likely that additional tanks could be washed away in future hurricanes.

Top: May 2003; Bottom: March 2010

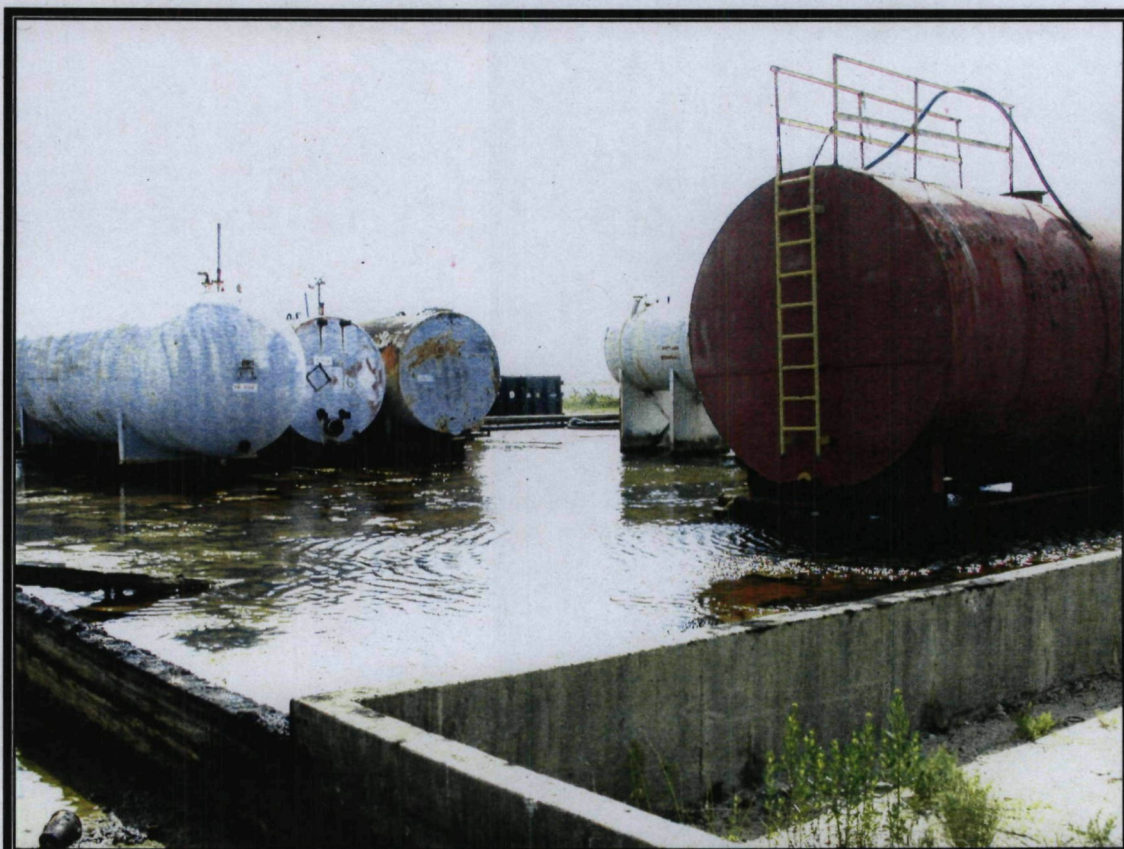
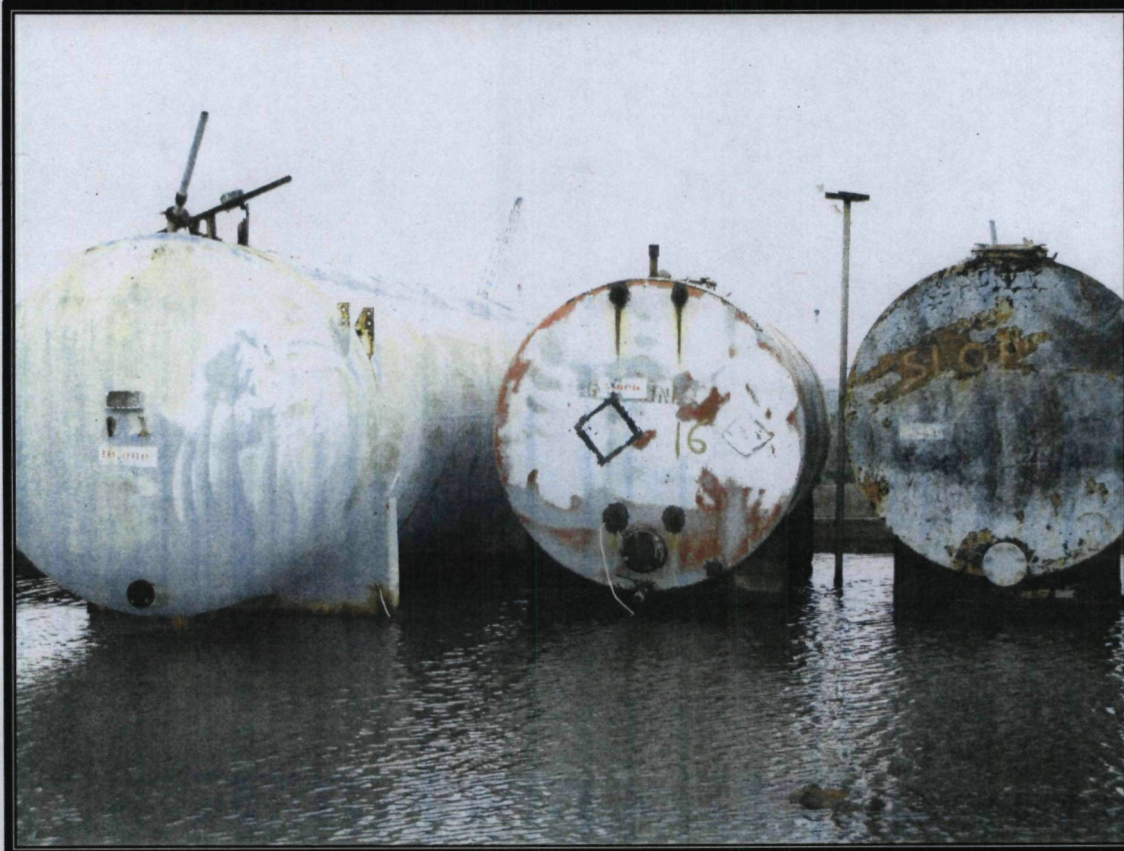
Tank No. 13 (third from left)

Top: May 2003; Bottom: March 2010

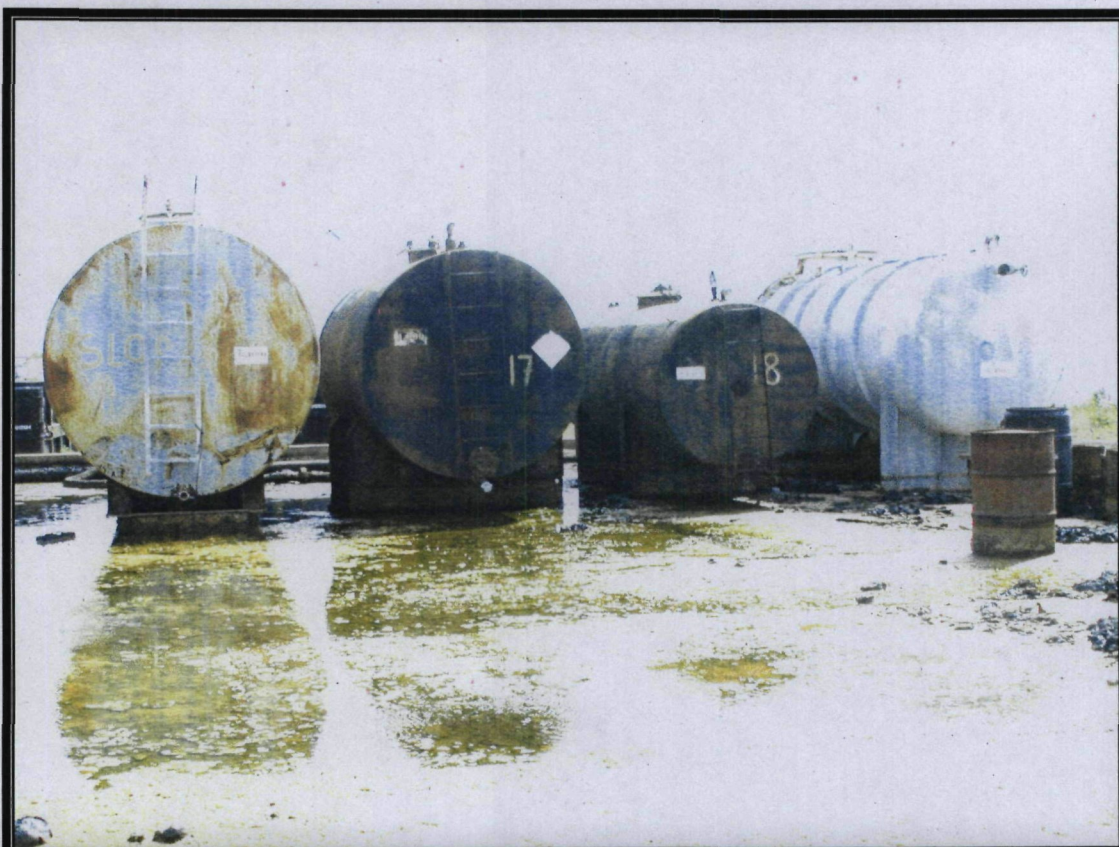
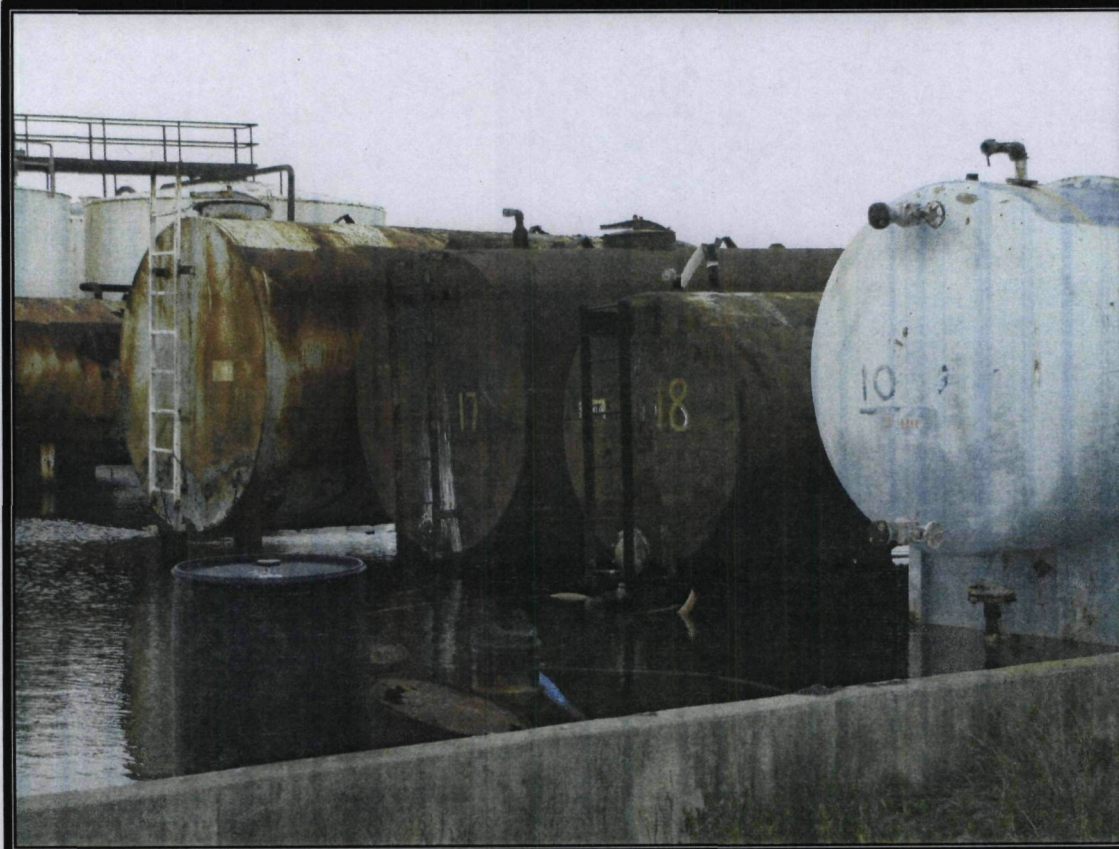
Tank No. 18 (second from right)

Top: May 2003; Bottom: March 2010

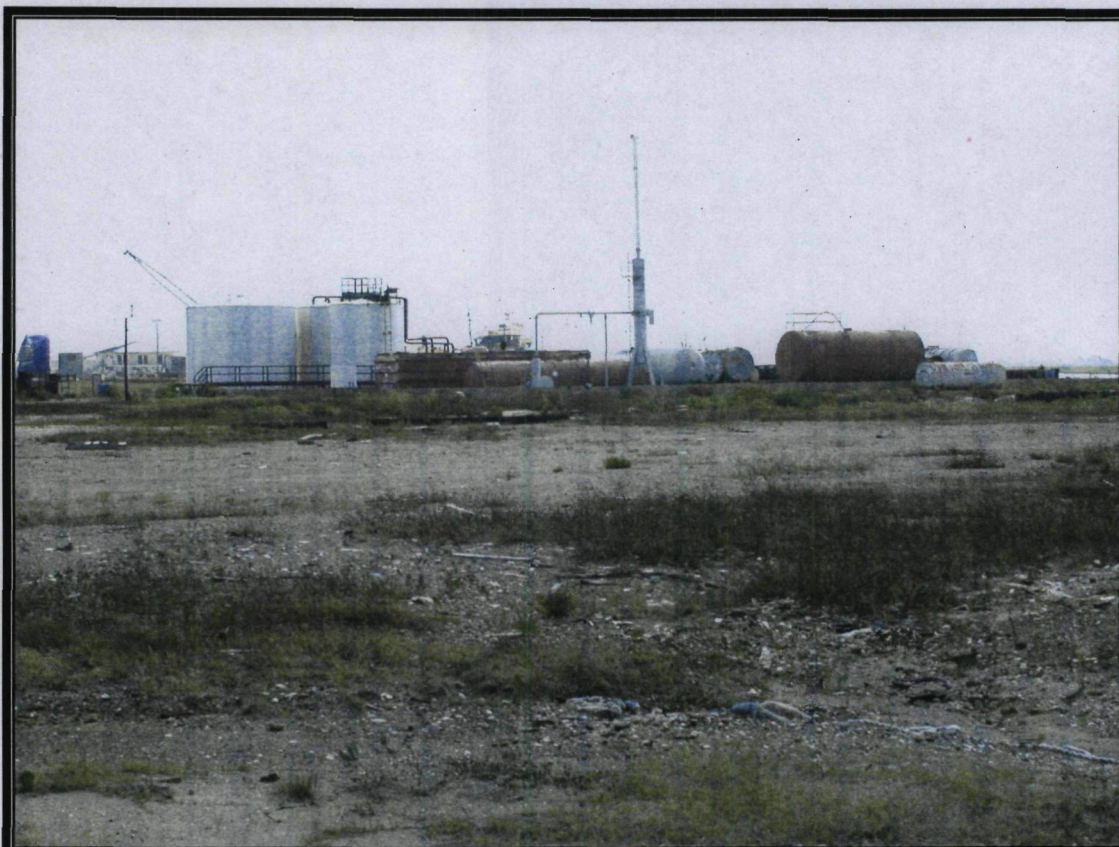
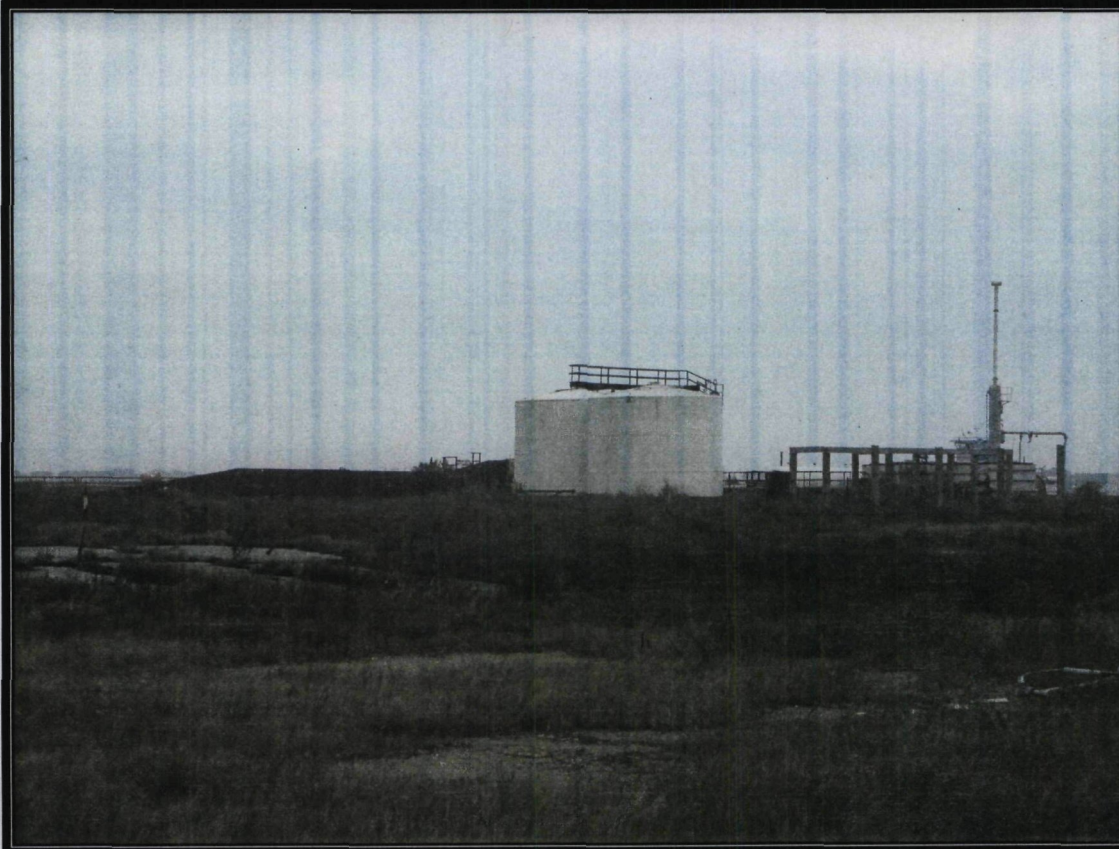
Gulfco Marine Maintenance Superfund Site
Tank No. 21 (top: left; bottom: second from left)
Top: May 2003; Bottom: March 2010
